REPLACEMENT TIME

GSP | NORTH AMERICA

CV AXLE

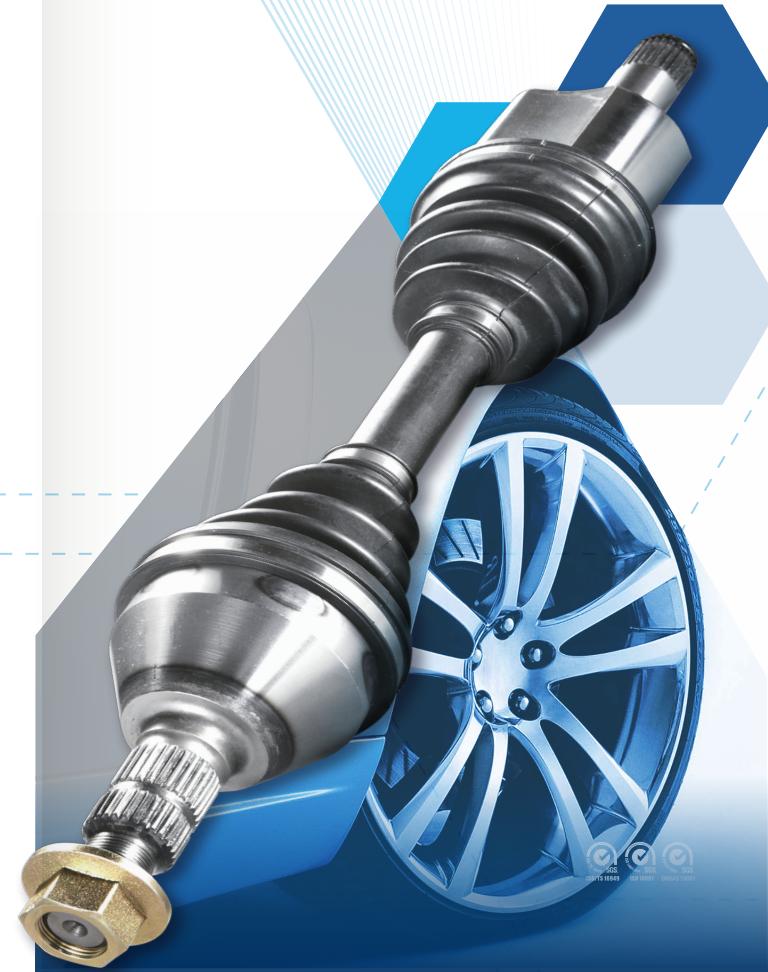
- Constant velocity (CV) axles take power from the vehicle's transmission and differential and transfers it to the wheels. This allows the vehicle to drive forward. It is important to keep an ear out for signs that it may be going bad.
- There are various reasons that could cause vibration when you drive. However, if the vibrations are excessive, increase with speed, or give an unusually "bouncy" feel to your drive, it may be due to the CV axle. Whatever is causing the vibration, it's important to get your vehicle inspected.
- This most unmistakable noise from a failed CV Axle is a loud clicking noise when turning. This indicator is a sign that the CV Axle should be replaced to ensure safety and proper performance.

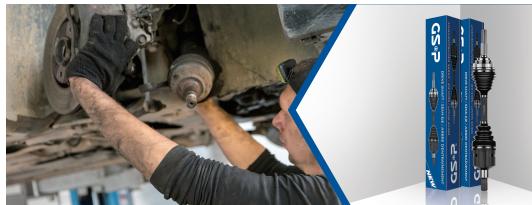
KNOW THE SIGNS OF FAILURE IN THE SHOP AND ON THE ROAD

- Grease evidence on the inside of the tires or wheels
- Torn rubber boot
- Visible damage to metal components
- Loose installation

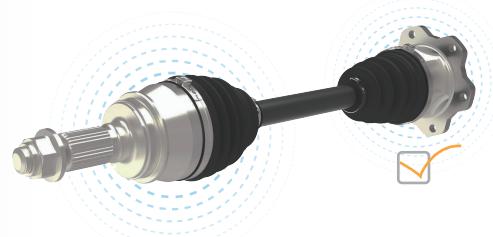
FEATURES AND BENEFITS

- Uses a premium, specially formulated moly grease for optimum performance at high temperatures and resistant to friction and wear.
- High quality neoprene boots are incorporated into GSP's CV Axle design to provide the best fit, form, and function in extreme conditions.
- All CV Axle components are heat treated to the highest standards to increase strength, durability and extended service life.

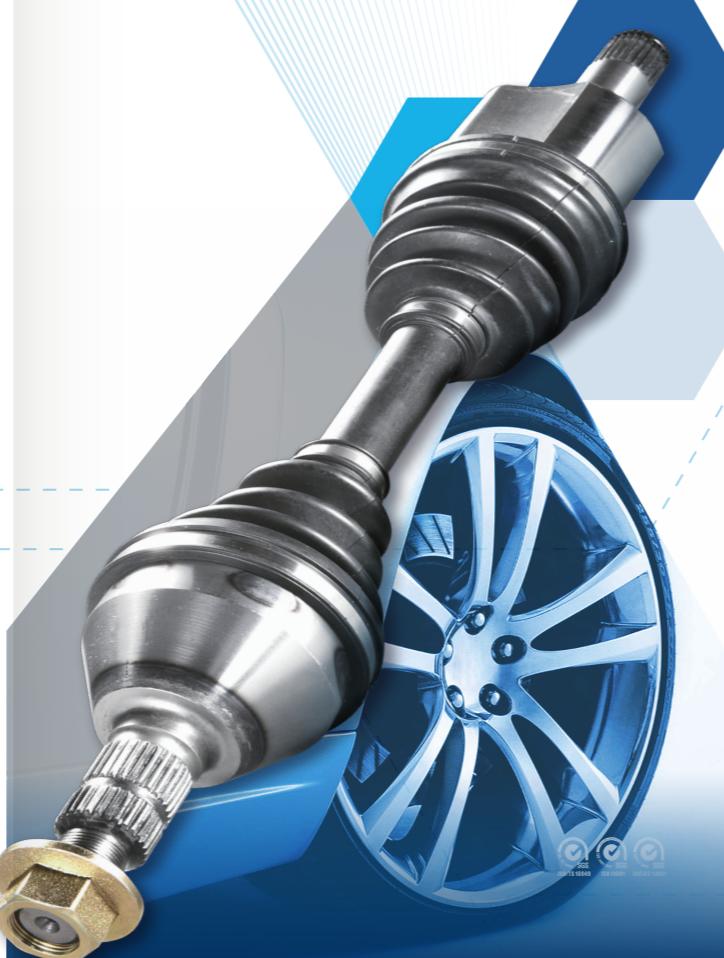
- Constant velocity (CV) axles take power from the vehicle's transmission and differential and transfers it to the wheels. This allows the vehicle to drive forward. It is important to keep an ear out for signs that it may be going bad.
- There are various reasons that could cause vibration when you drive. However, if the vibrations are excessive, increase with speed, or give an unusually "bouncy" feel to your drive, it may be due to the CV axle. Whatever is causing the vibration, it's important to get your vehicle inspected.
- This most unmistakable noise from a failed CV Axle is a loud clicking noise when turning. This indicator is a sign that the CV Axle should be replaced to ensure safety and proper performance.

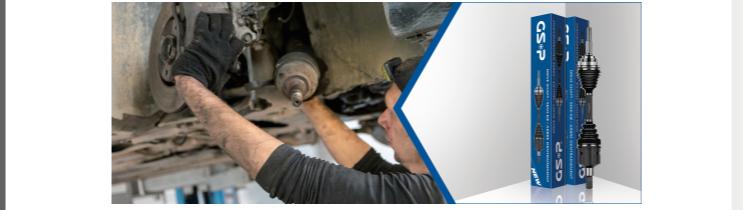
DID YOU KNOW?

- GSP manufactures Extreme Duty (XD) Axles for use in harsh weather or rugged environments.

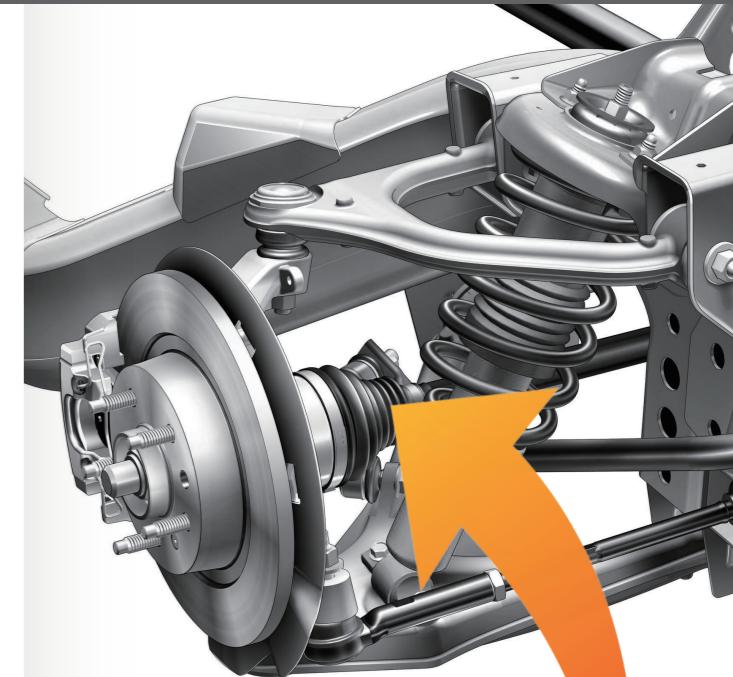
- Grease evidence on the inside of the tires or wheels
- Torn rubber boot
- Visible damage to metal components
- Loose installation
